ARCHAEOLOGY ARDNAMURCHAN Monument Recording Form	Location South of Lochan na Gruagaich	Monument No 552654
		Record Date 11.11.13
		Surveyor Jon Haylett

To the south of Lochan na Gruagaich, a settlement consisting of houses, byres, enclosure, stone 'circle', field walls, fields with rig and furrow, a spring, etc.

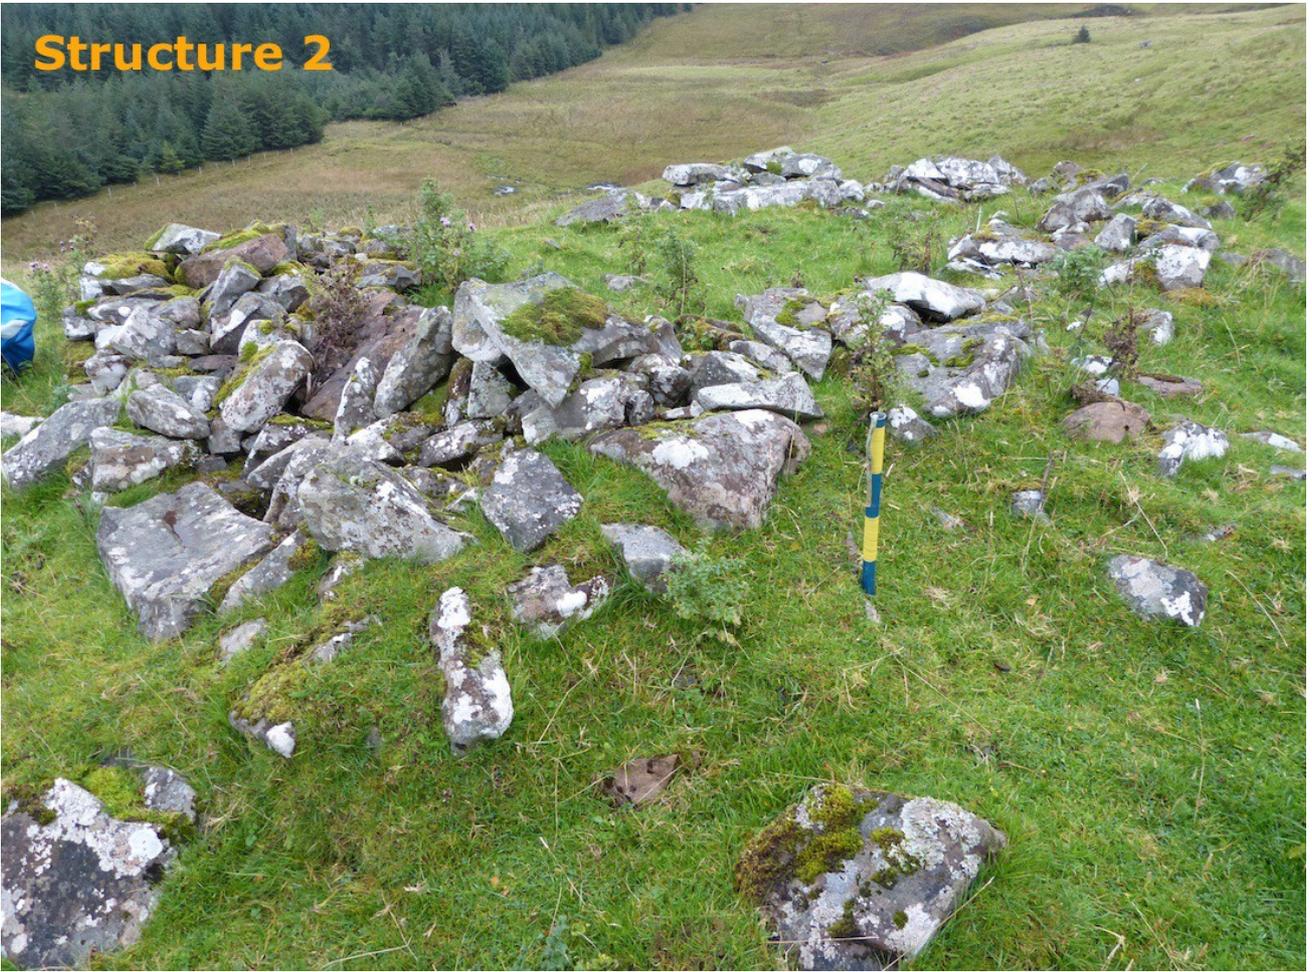
Structure 2

Structure 2: Stone built byre or small house 6m x 2.5m aligned 145deg, door to north.

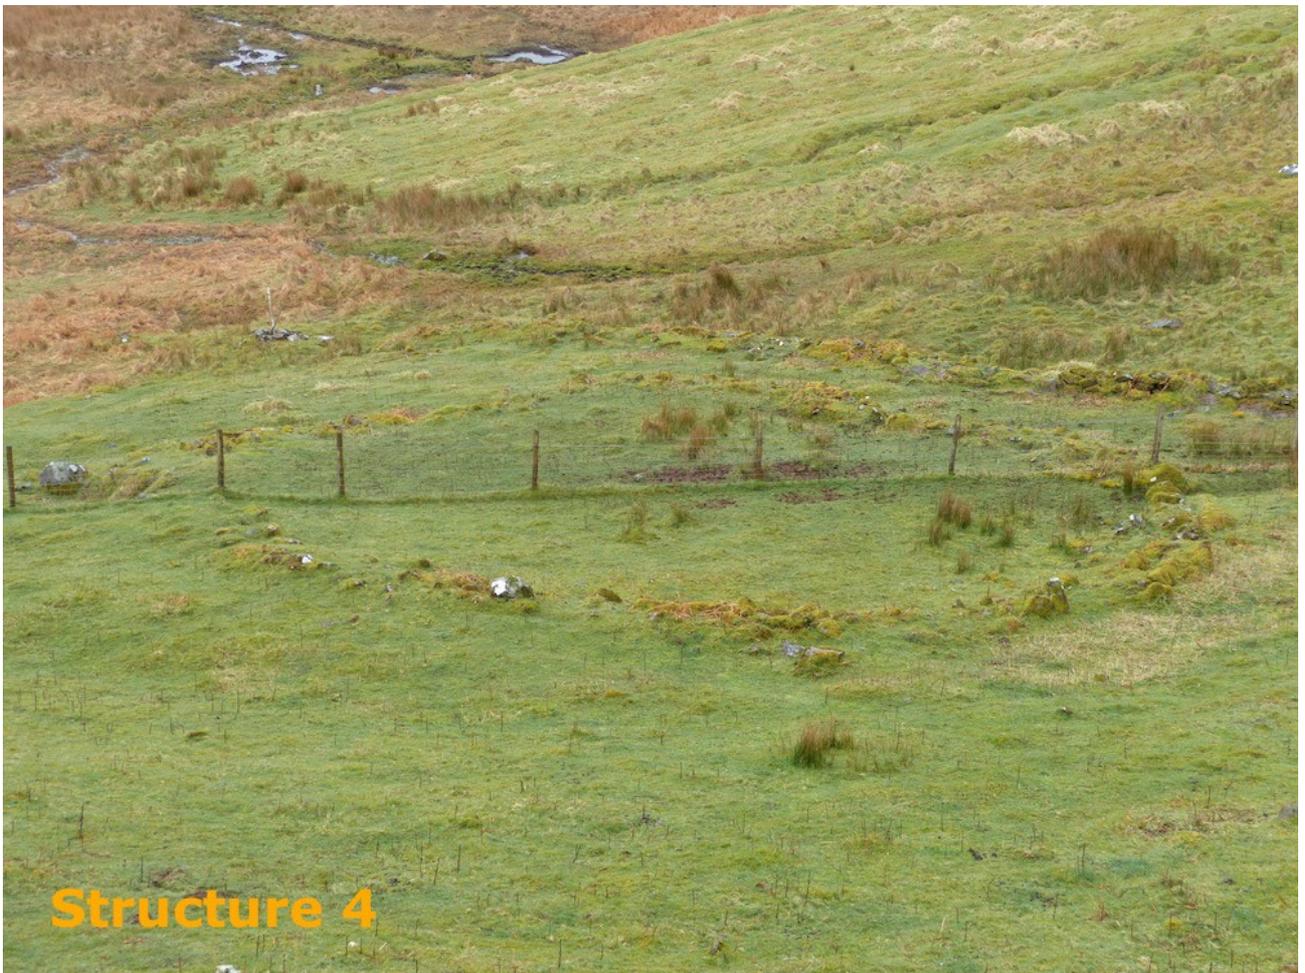
Structure 4

Structure 4: 14m diameter stone walled structure, wall formed of rocks <50cm but largely overgrown, standing <50cm high. Could be an animal enclosure but no sign of entrance. The structure may be much older than the farm settlement.

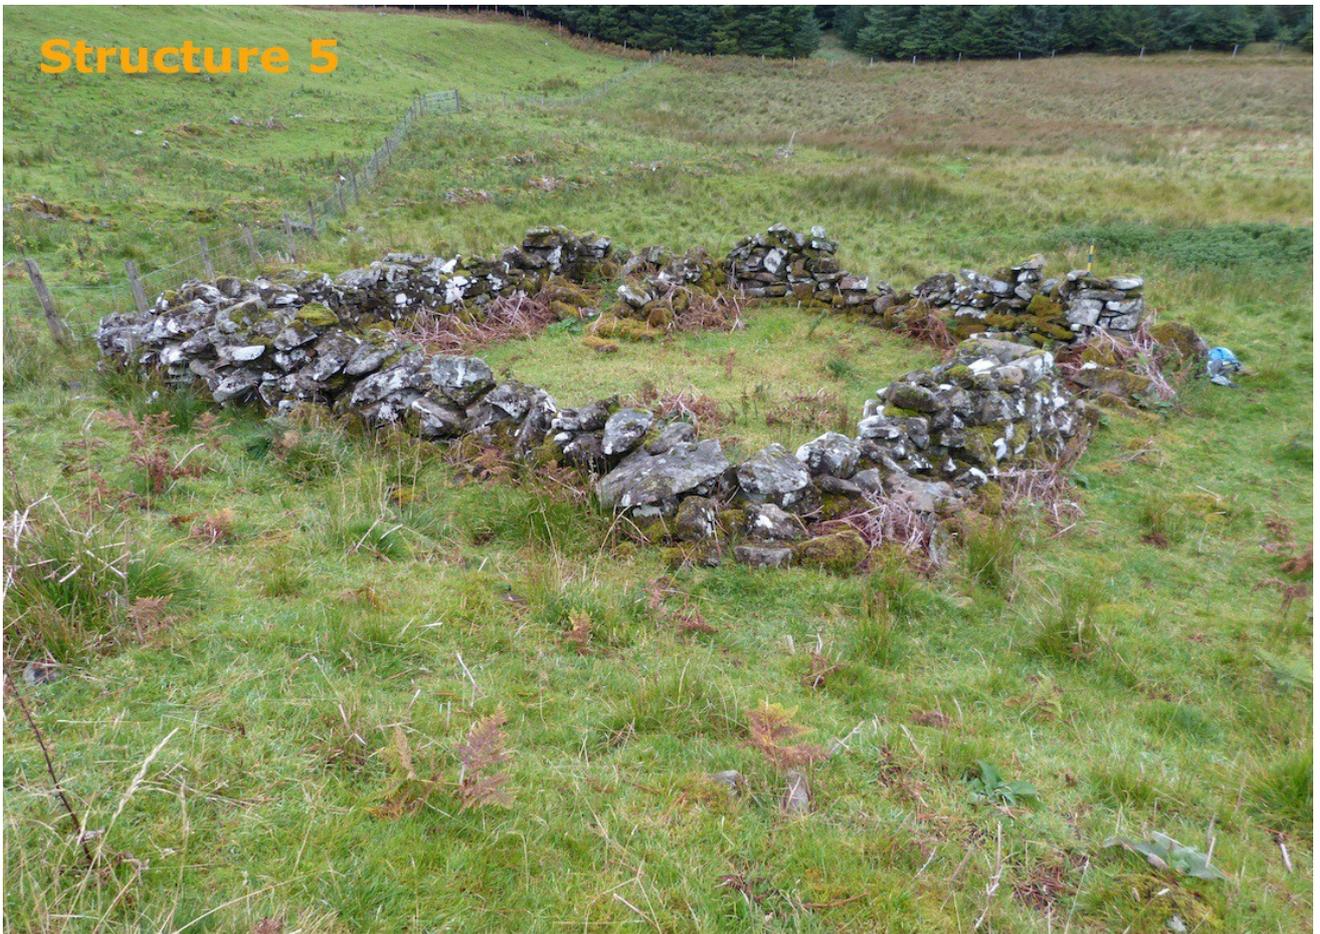
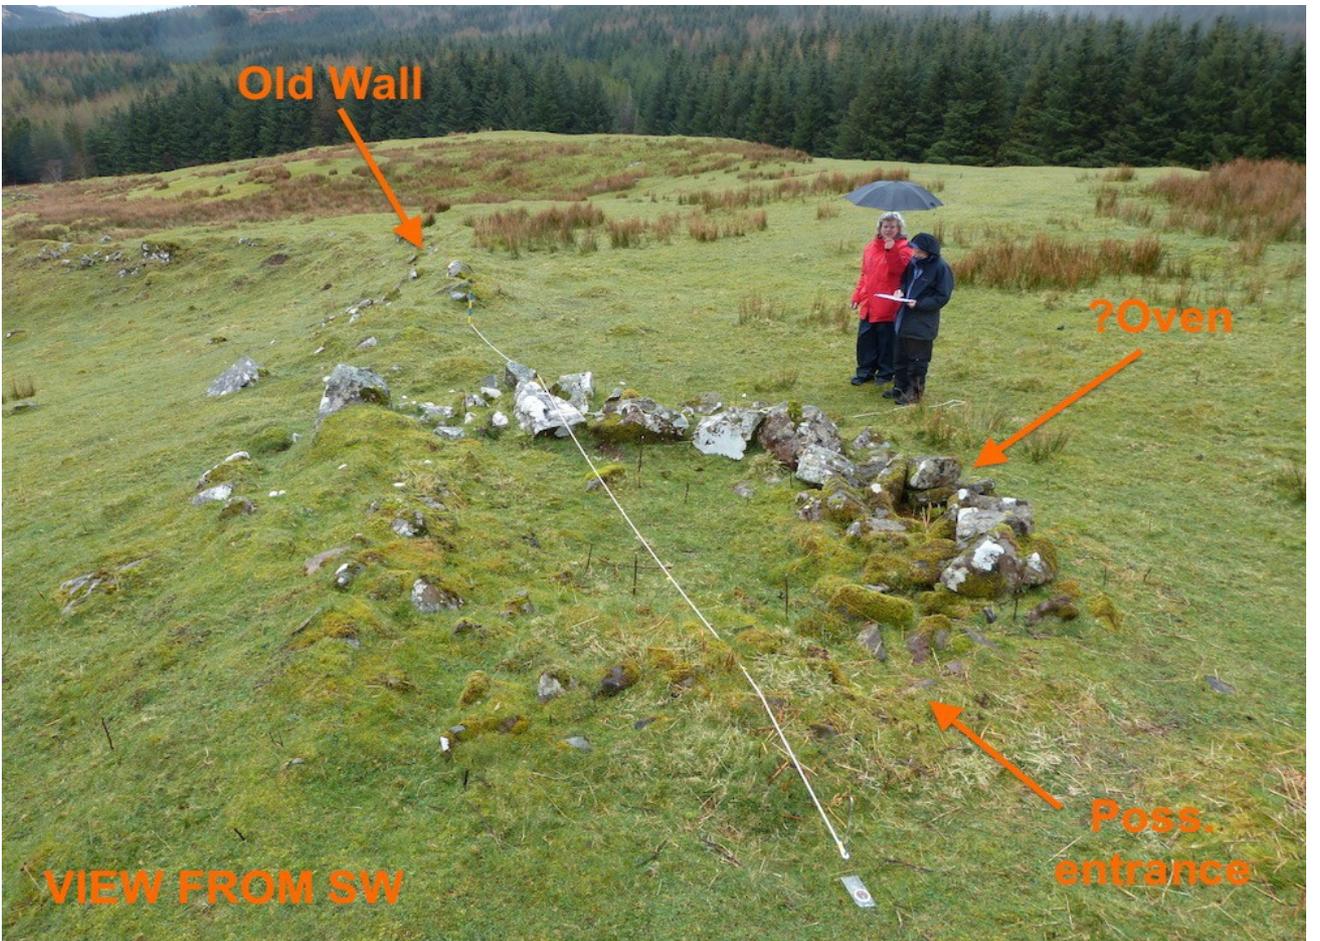
Structure 5

Structure 5: Square stone-walled animal enclosure, walls <1.5m high, 7.5m x 7.5m, one side aligned 310deg, with ~2m wide entrance to southeast. Has smaller enclosure in NW corner. Outside NW corner, there is a roughly circular structure ~4.5 diameter
