## Monument Record Form

Coast north of Ockle

553711

Settlement

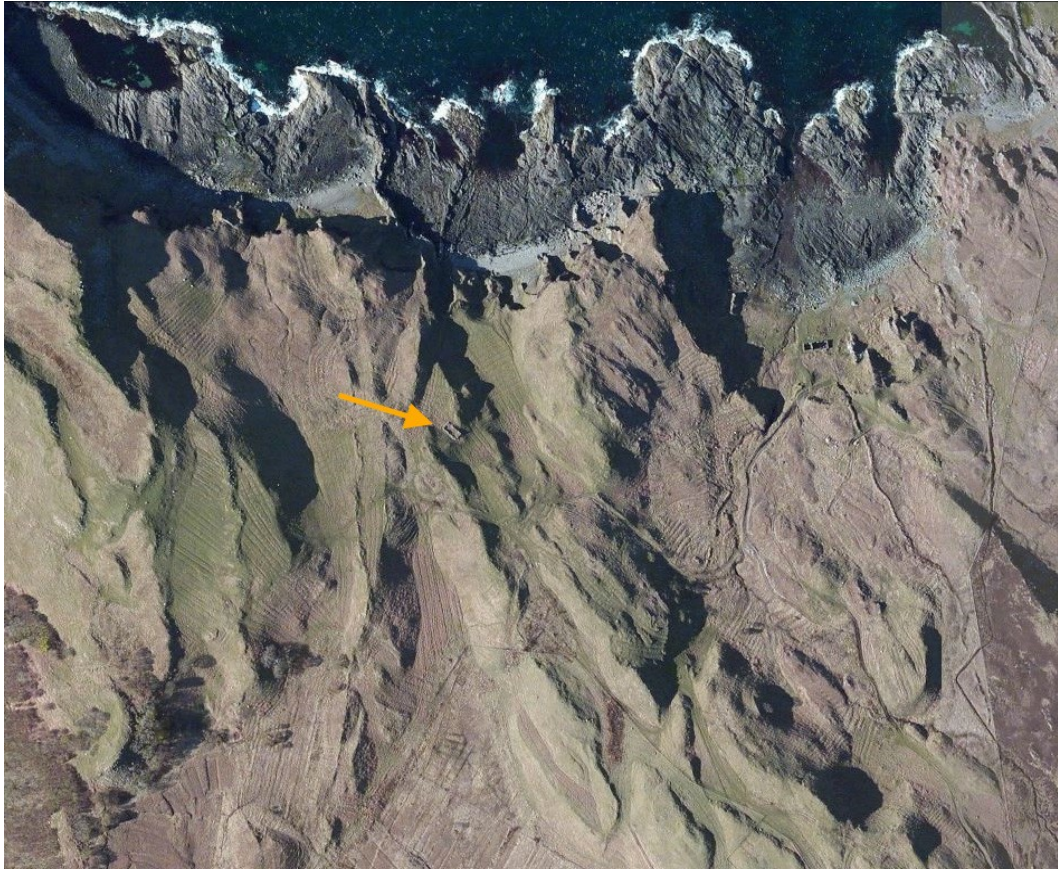
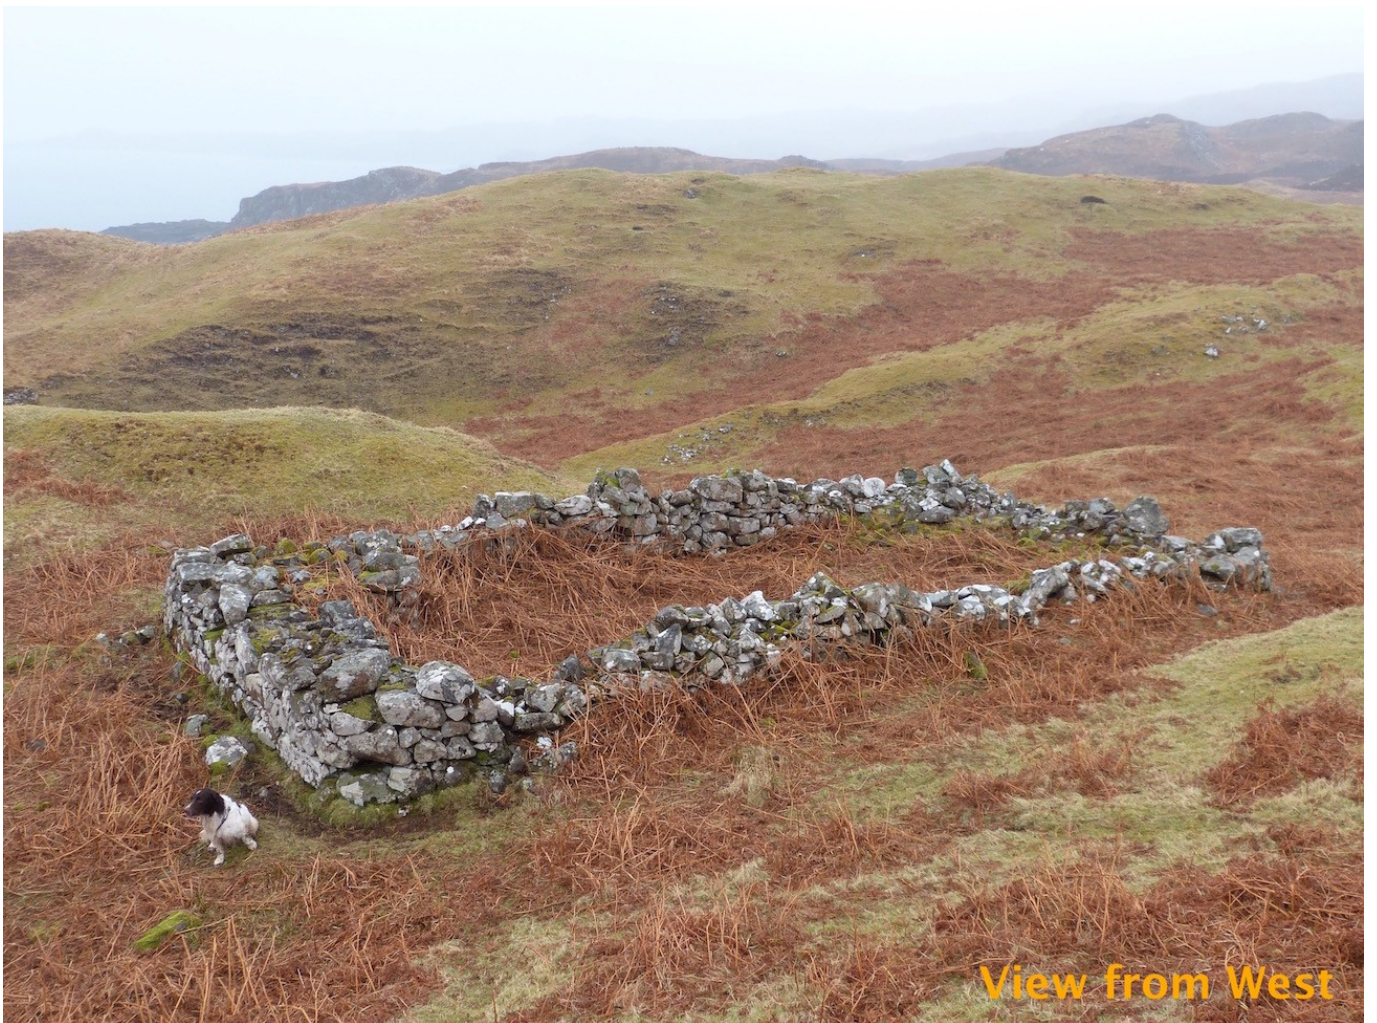
A lone dwelling house perhaps associated with the clachan of Ockle, with rounded corners, walls standing to ~1m, and door in NE wall; there may also be an entrance, perhaps formed later, in the SW wall. It is surrounded by run-rig fields, and sits in a depression against a slight knoll. The north corner is infilled to make a square structure of unknown purpose but which has been found in several similar structures.

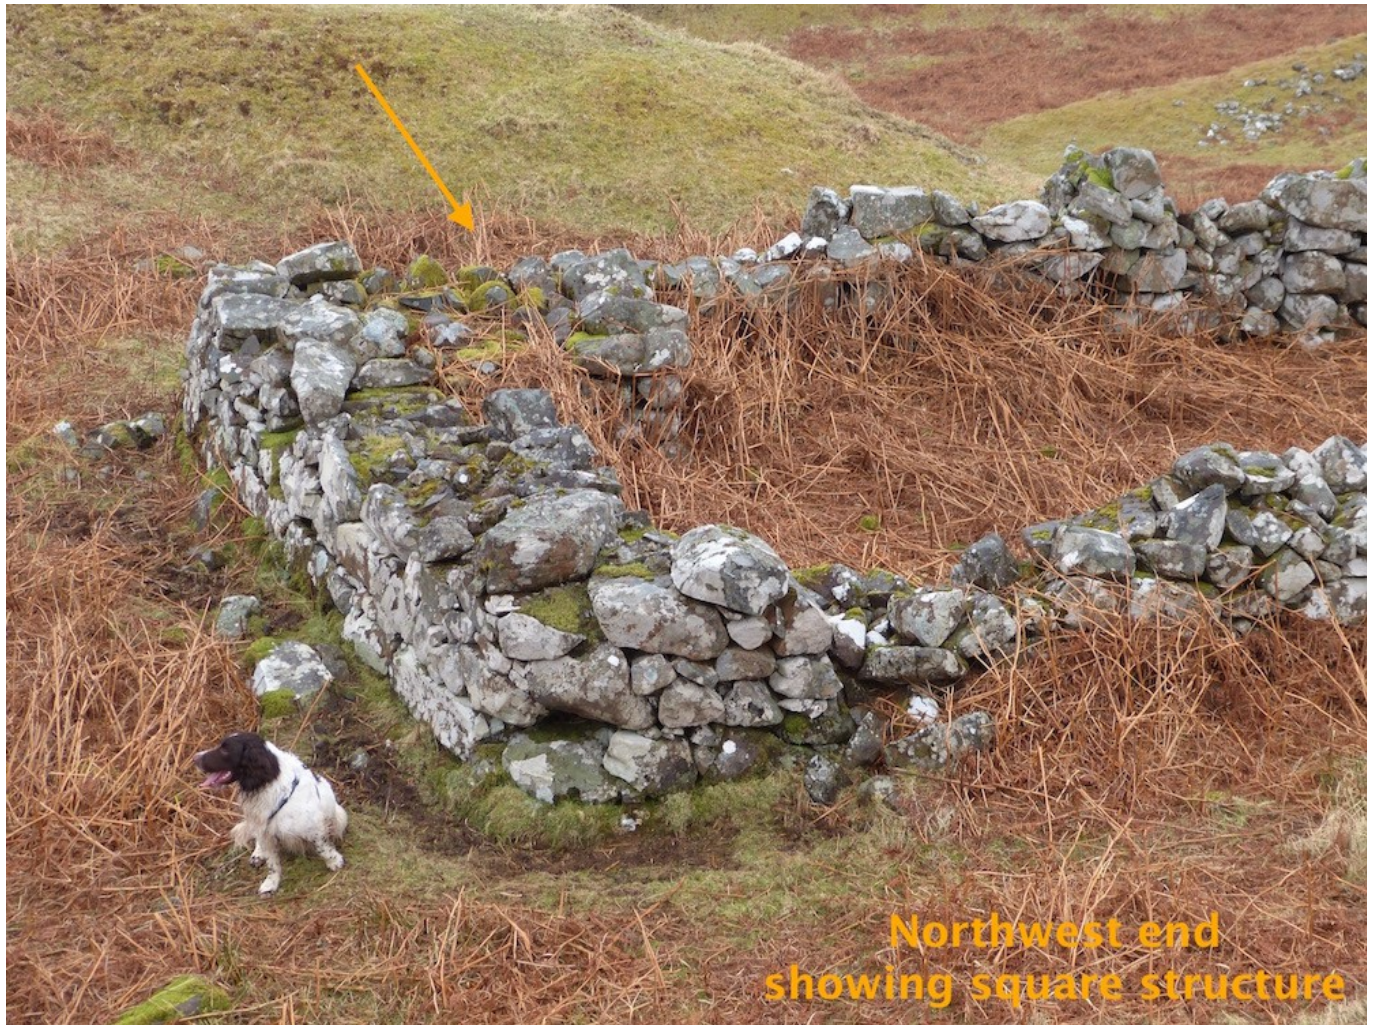
*Square structure arrowed.*
