ARCHAEOLOGY	Location	Monument No	505630			
ARDNAMURCHAN Monument Recording	100m East of Mingary Castle	Record Date 08.11.13				
Form		Surveyor	Jon Haylett			
Monument Type	What it's made of	Monume	ent Condition	V Good		
Lime Kiln	Stone		(circle one)	Good Good/Fair		
Dimensions in Metres				Fair/Poor		
Length Width	Height	Diameter P	hotograph Nun	Poor		
4m 3m						
Grid reference NGR	Easting	Northing	Accuracy	v (m):		
(local NGR is NM) NM	50587 6	53096	3m			
Detailed description, further notes, observations – continued on next page

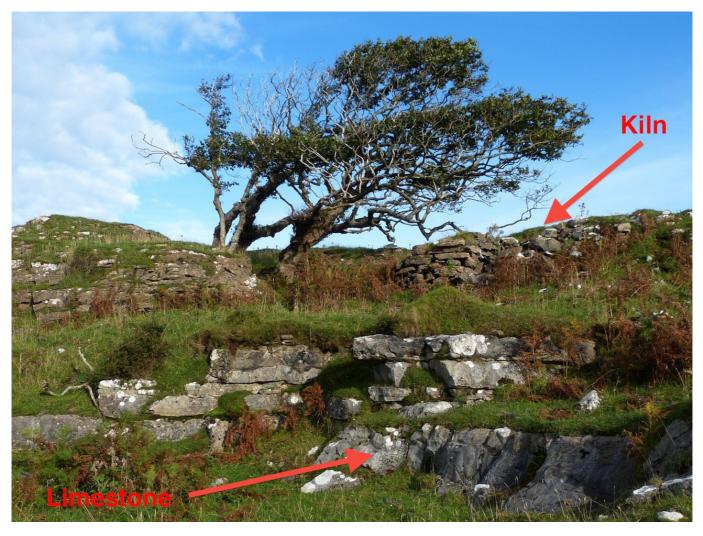
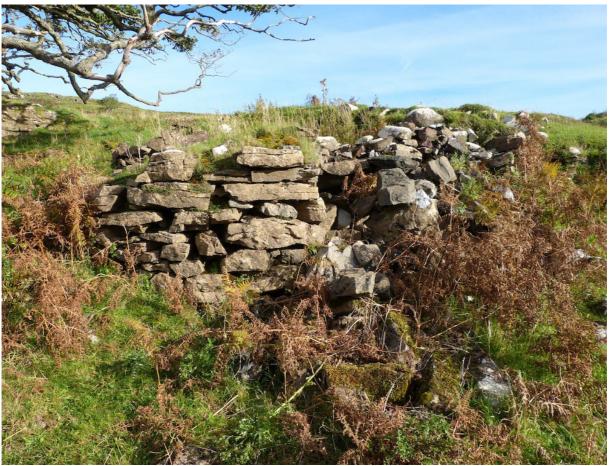
Lime kiln 100m to east of Mingary Castle, possibly the kiln used to make the mortar for the castle. 4m wide by 3m deep, set into bank so that raw materials could be poured in from above and lime removed from front. Surrounding rock is limestone.

This is not thought to be the kiln used to build the original castle but perhaps that used in the 18th century alterations.

Unlikely to be original lime kiln for 1300AD castle
