# Ardnamurchan History & Heritage Association

## 526693 Branault Cottages

Four cottars' dwellings lie along the top of the hill that slopes down to the Achateny Water to the west of Branault township. They stand in a line which runs from NW to SE, and are numbered 1 – 4 in that direction.

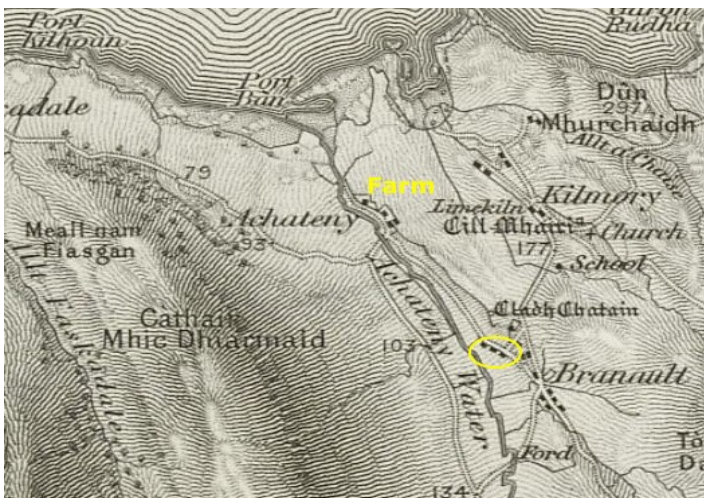
The cottages are not marked on Bald's map of 1806 but three of them, the ones which today are still visible, are present on the OS First Edition of 1856.

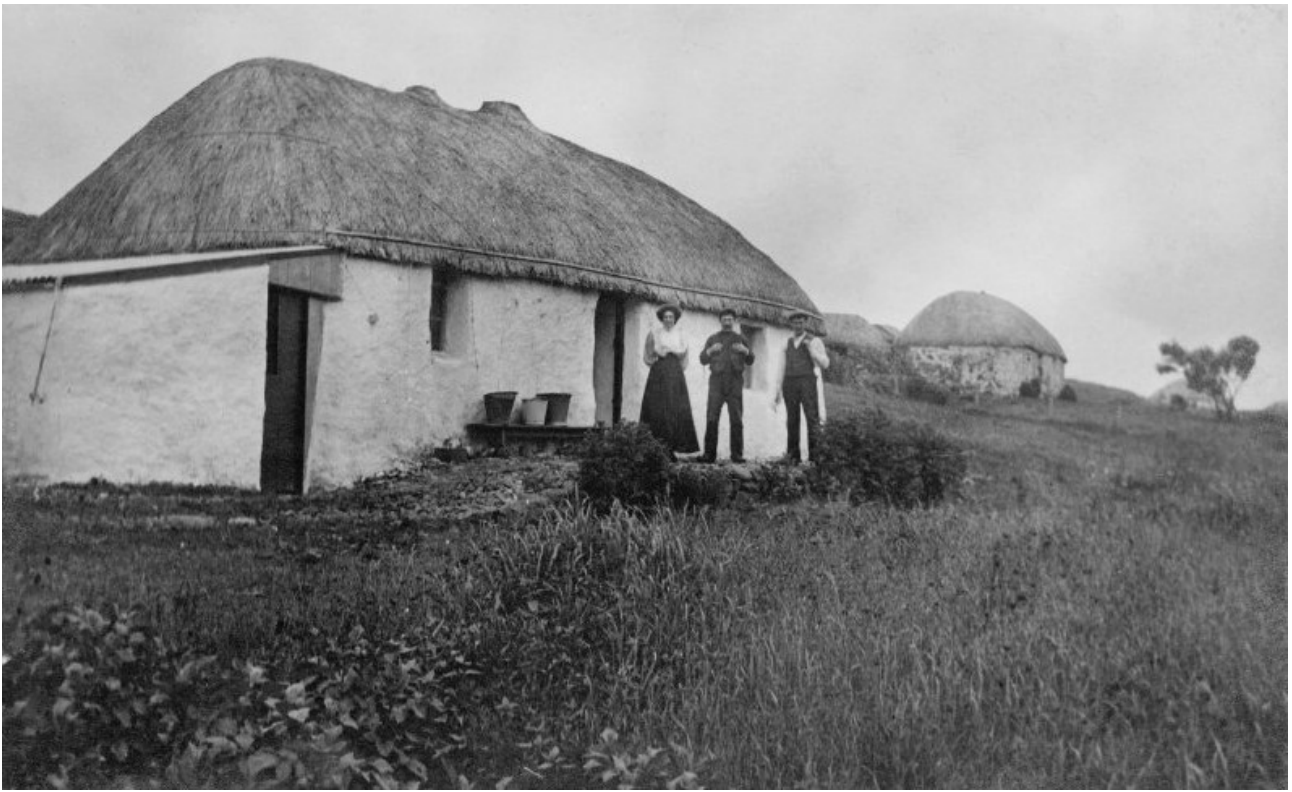
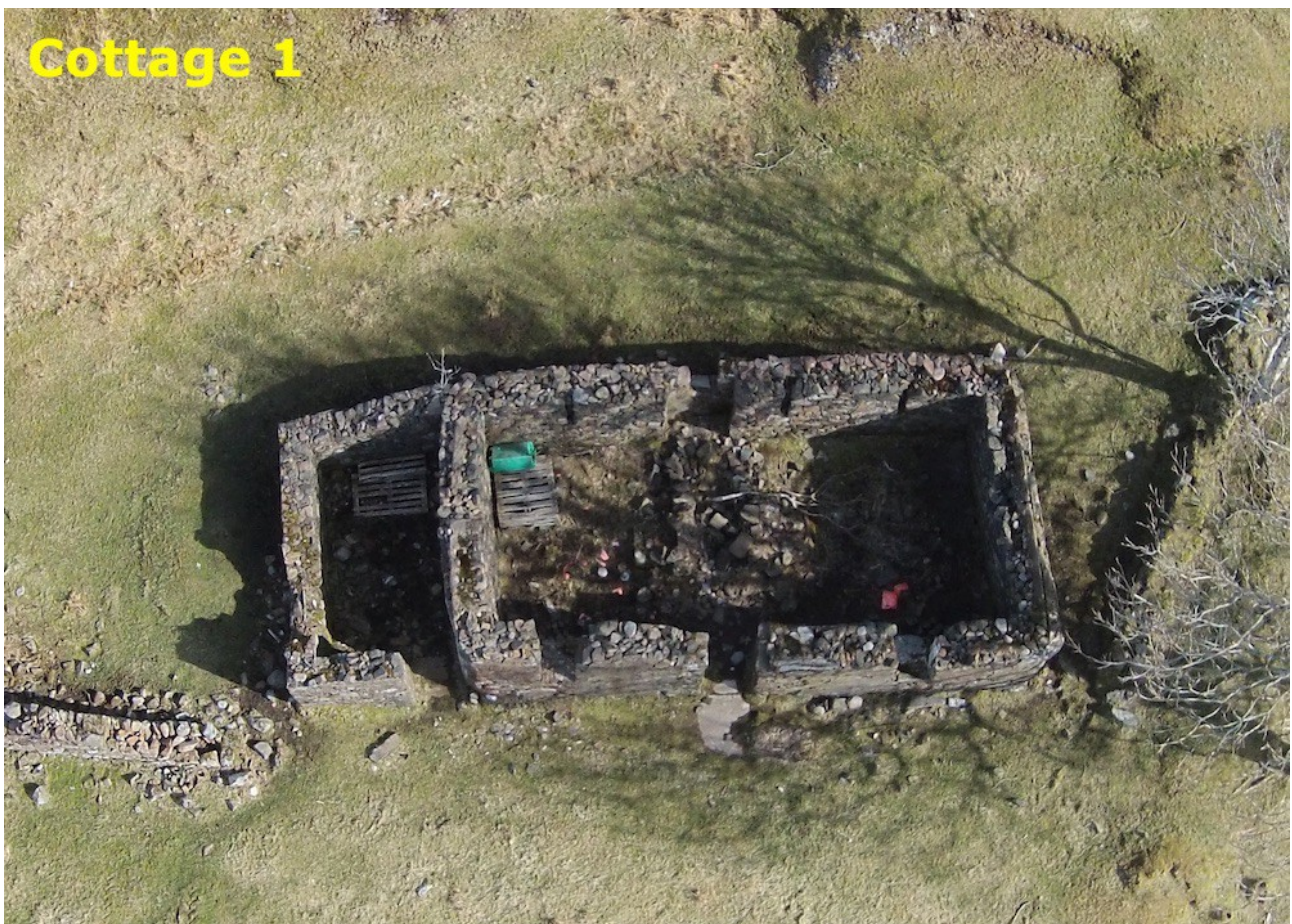
**Cottage 1** NM5267669358 (3m) 33m OD

9m x 5m, exterior walls with rounded corners, square on inside

Entrance to SW with windows on either side. Later entrance or alcove formed in opposite wall, with small window. Front windows narrower on inside, taper upwards; window to left of entrance has sill sloping outwards.

Exterior harled, with some signs of mortaring.

Roof supported by four cruck couples; slots on either side of door retain original wood. Some evidence that a later roof which did not use crucks. Local report that this building had a corrugated iron roof.

Interior division appears to be a double wall.

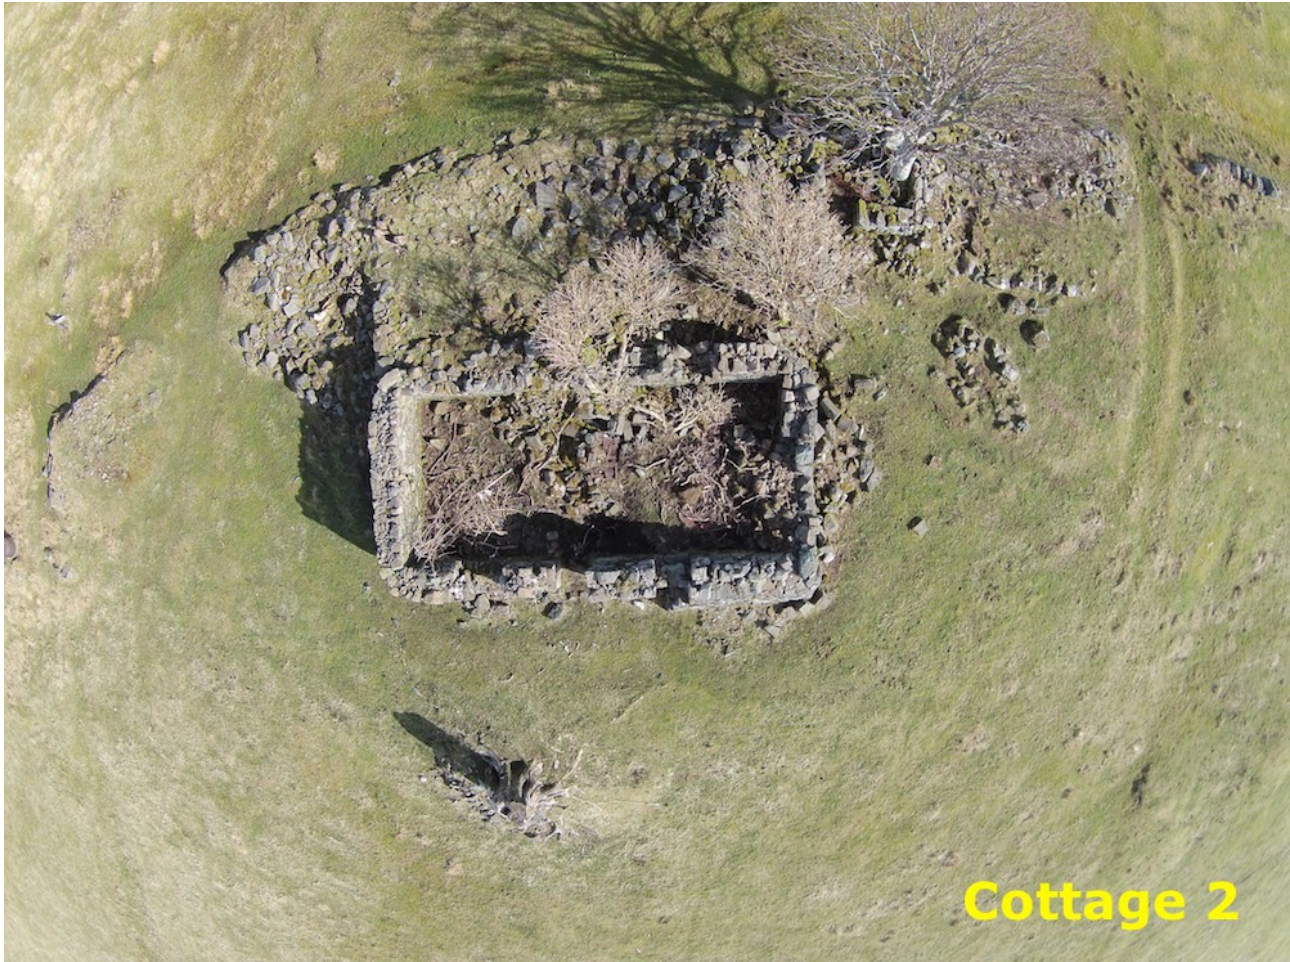
**Cottage 2** NM5271569333 (3m) 35m OD

9.5m x 5m, exterior walls with rounded corners, interior corners square

Less well built than 1 and 3, thicker walls, larger stones.

Front wall buttressed along S end of front wall. Rear wall largely collapsed.

Entrance to SW with windows on either side. No rear entrance.  
 Cruck couple slots visible but evidence that slots were later infilled.  
 Interior division with well preserved cast iron cooking stove

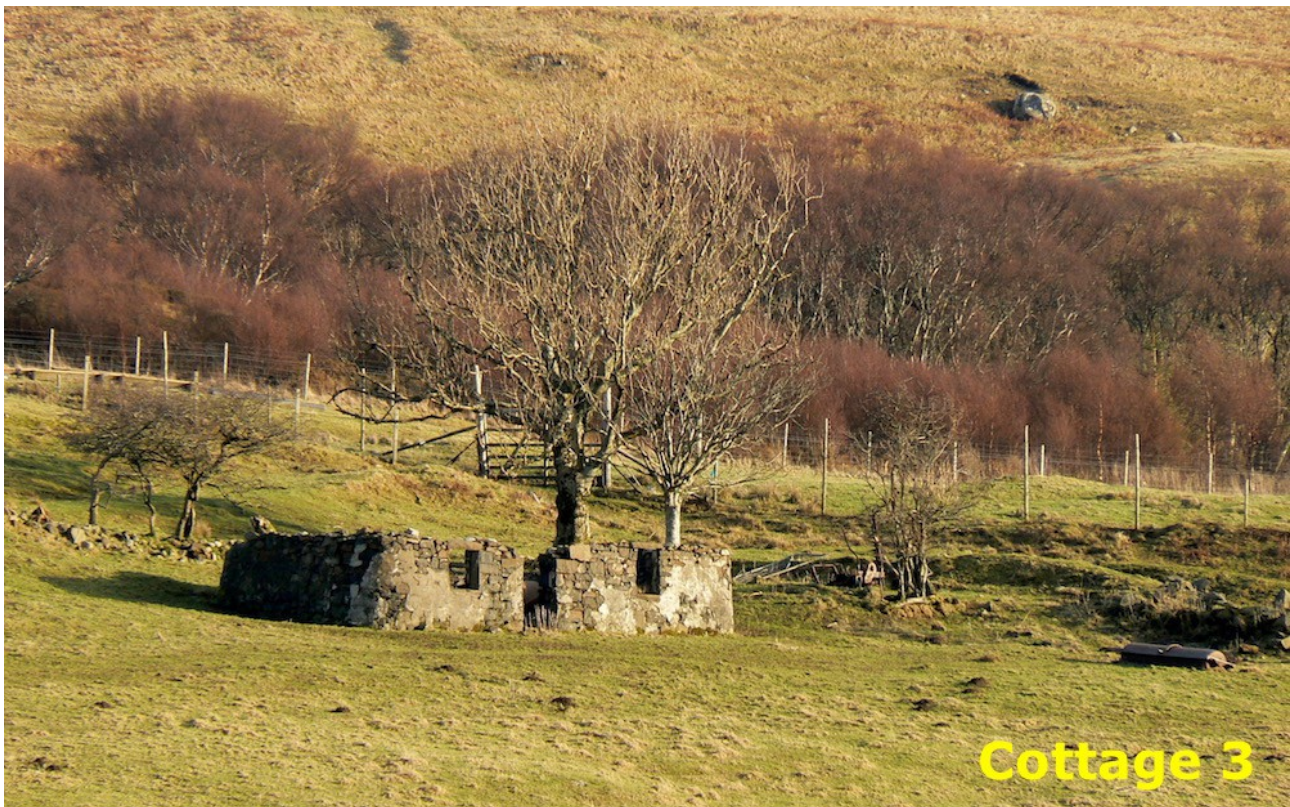
### Cottage 3 NM5275969297 (3m) 38m OD

9m x 4.5m, exterior walls with rounded corners, interior squared  
 Walls in good condition.  
 No slots visible for cruck couples.  
 Outer walls harled but no mortar.  
 Central pillar with cast iron stove to SE  
 Cottage is reported as having been thatched until abandoned by Mrs Livingston in 1972.
