**Monument Record
Form**

Back of beach to south
of Rubha an Duin Bhain

448703

Shieling hut

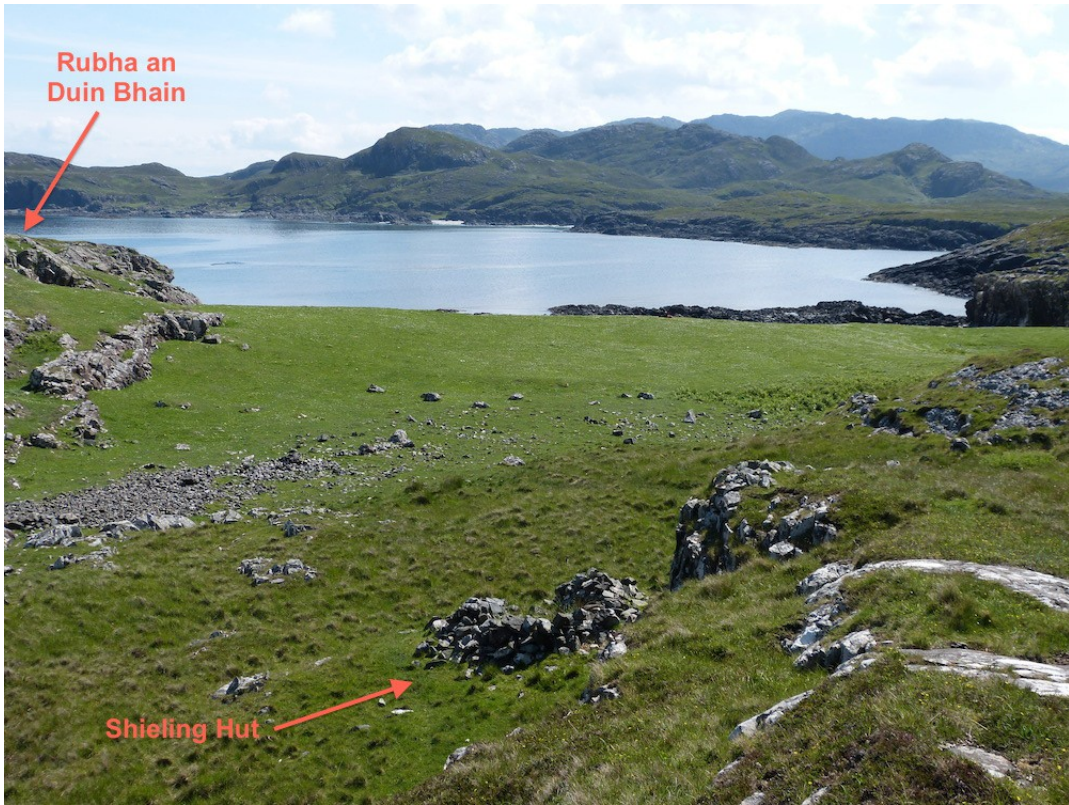
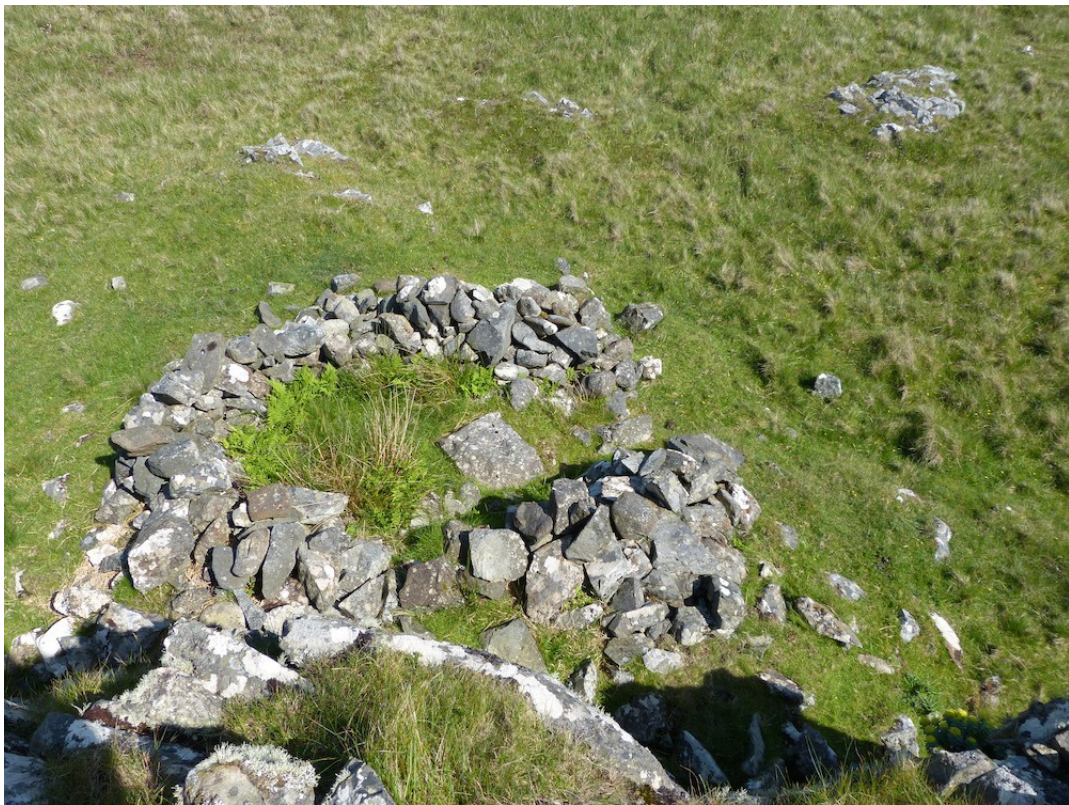
A reasonably well-preserved shieling hut tucked against a low rocky ridge at the back of the beach at Rubha an Duin Bhain. The hut is slightly unusual in that it is elongate along E-W axis, with the entrance at the East end. Just to the south, running along the back of the beach, is the remains of a stone wall which may be associated. The machair at the back of the beach is closely cropped by sheep.
